**UNIVERSITI TUN HUSSEIN ONN MALAYSIA**

**FINAL EXAMINATION  
SEMESTER II  
SESSION 2018/2019**

COURSE NAME : STRUCTURAL MAINTENANCE  
COURSE CODE : BNC 41103  
PROGRAMME CODE : BNC  
EXAMINATION DATE : JUNE / JULY 2019  
DURATION : 3 HOURS  
INSTRUCTION : ANSWER ALL QUESTIONS

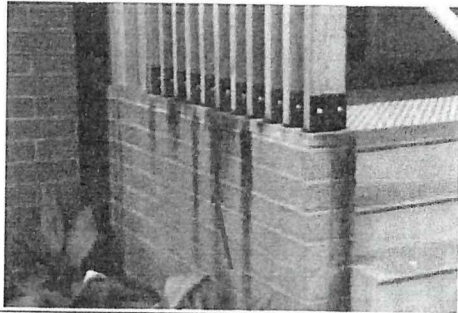
**Situation A Finding:**

Brown stains are running down blockwork wall from the timber feature panels.

- (d) A civil engineer often at the construction site itself, taking a hands-on approach to engineering tasks. Analyse the problem solution for A, B, C, D, and E as in **Figure Q4 (c)**. (10 marks)

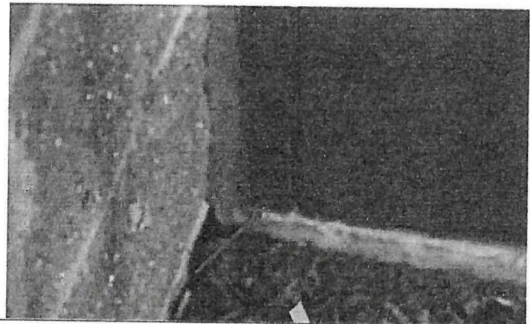
**Situation B Finding:**

Door frame to electrical meters has 1 hole visible at the lower section of the frame.

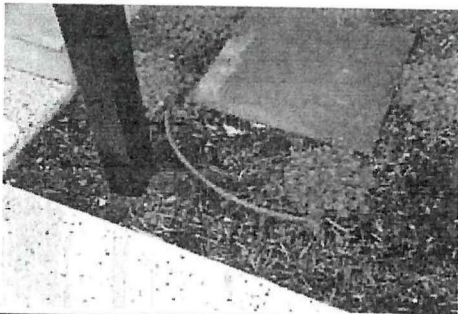
**Situation C Finding:**

Unsatisfactory installation of sprinkler system in garden bed.

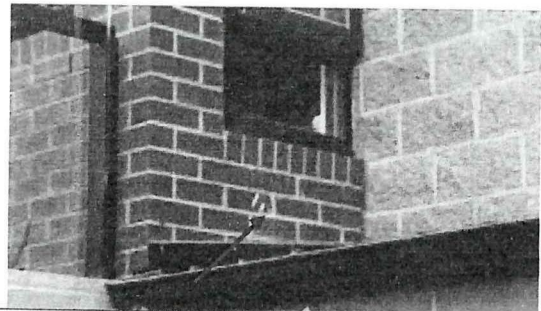
**Situation D Finding:**

Paint splatter to brickwork is evident underneath window.

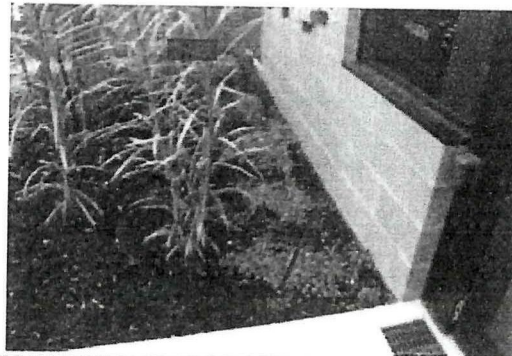
**Situation E Finding:**

Water is entering the carpark block wall via non-waterproofed garden bed causing efflorescence on the block work in the carpark.
